NBS MONOGRAPH 89

# Effects of Thermal Shrinkage On Built-Up Roofing

National Bureau of Standards Monograph 89
Issued March 4, 1965

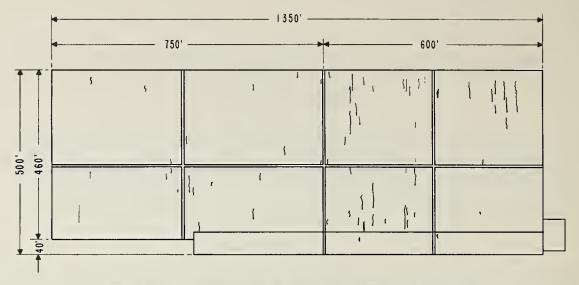
FIGURE 1. Splitting failures attributed to membrane shrinkage.

The four sections on the left were about 3 years old. The remaining sections on the right were approximately 9 years old.

Although the seriousness of wrinkle cracking is recognized, it is believed that splitting results in a more serious failure. The author's experience with the performance of built-up roofs has confirmed the widespread incidence of splitting failures, especially in cold climates. Figures 1, 2, and 3 show schematically failures attributed to membrane shrinkage. Figure 1 shows the number of splits which were observed in the roof on one large structure, while figures 2 and 3 indicate the displacement of the flashings at an expansion joint and at the gravel stop, respectively, on the same structure, due to membrane shrinkage.

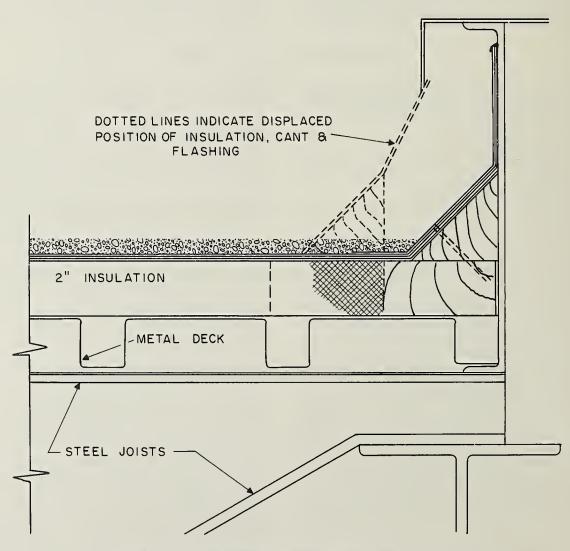
Figure 2. Displacement of flashing at an expansion joint due to membrane shrinkage.

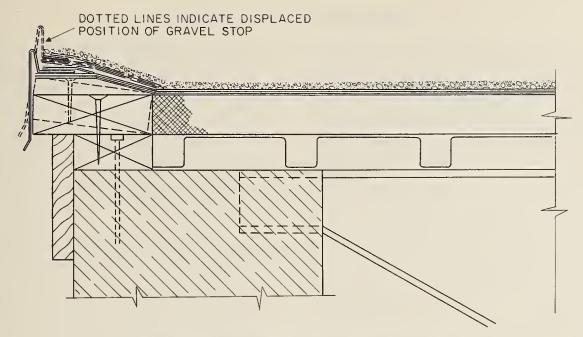
FIGURE 3. Displacement of gravel stop due to membrane shrinkage.

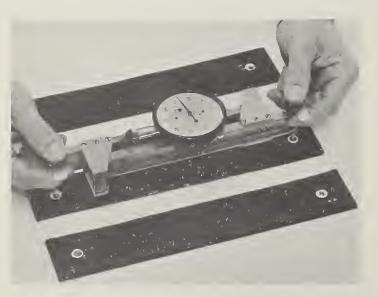
FIGURE 4. Thermal movement measurement technique.

The thermal movement measurements were made on four 12-in. long by 2-in. wide specimens of each sample, two of which were prepared with the 12-in. dimension perpendicular to the machine direction of the felt and the remaining two were prepared with the 12-in. dimension parallel to the machine direction of the felt. Brass reference plugs, ¼ in. in diameter, were inserted and sealed with an epoxy adhesive into holes drilled into the specimen near each end and spaced about 10 in. apart.

At 10 °F increments during the cycle while the specimens were in the chamber, the distance between the reference plugs was measured to the nearest ten-thousandth of an inch using a Whittemore Strain Gage, as shown in figure 4. The variation of specimen temperature during the period when the measurements were made was minimal due to the large mass of the conditioning chamber.
